WHO KILLED THE COVER?

A CHEMICAL GUIDE

PLASTIPACK LIMITEDTM
© Plastipack Ltd

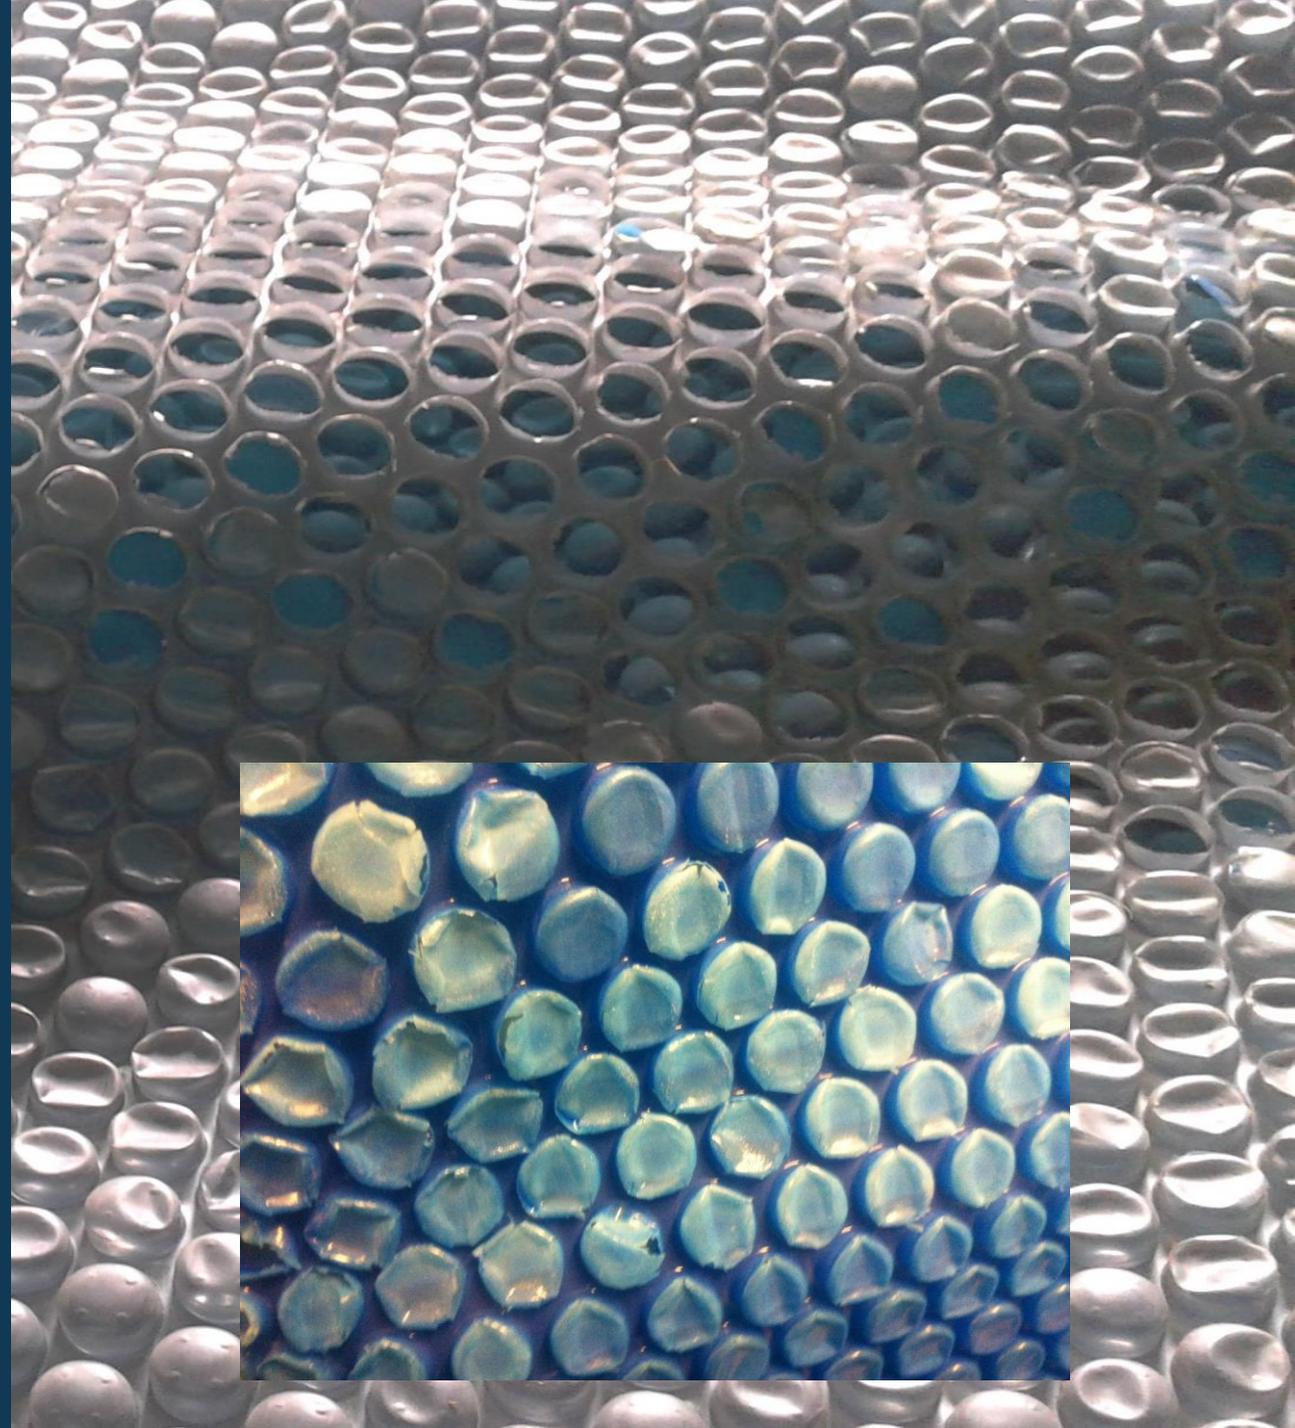
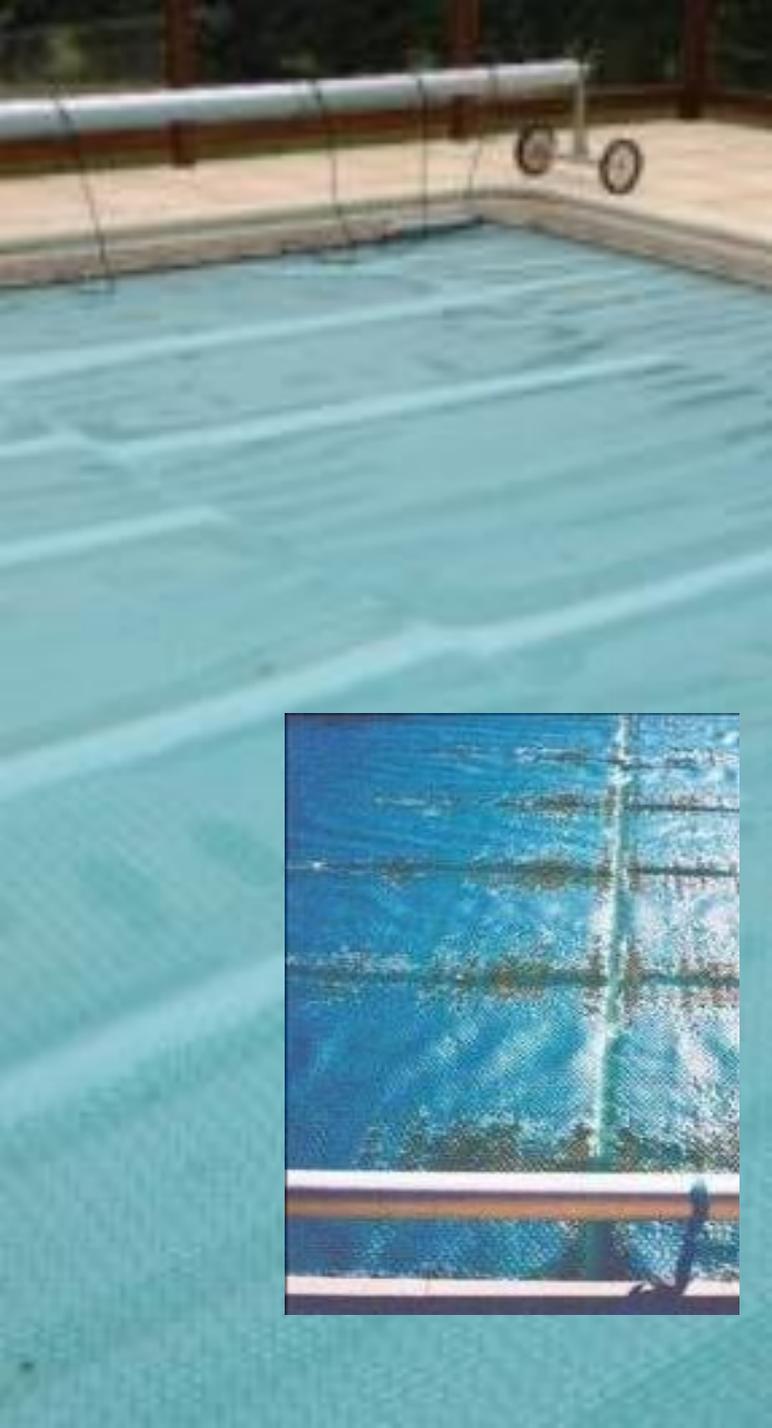
Chemical Degradation

Most issues involving premature degradation are the result of elevated chemical levels within the pool.

Frequently, a sudden deterioration of the cover can be the result of a shock treatment.

- Bleaching of the underside of the cover.
- Bleaching of the hemming/edge.
- Material has turned brittle - in particular on the bubble layer.
- High residue amounts on the cover.
- Oxidation of eyelets.
- Strong chlorine smell

When the pool is outside of the industry recognised balance or when shock dosing the pool, it is important to remove the cover and only return it to the pool once oxidiser levels have stabilised.

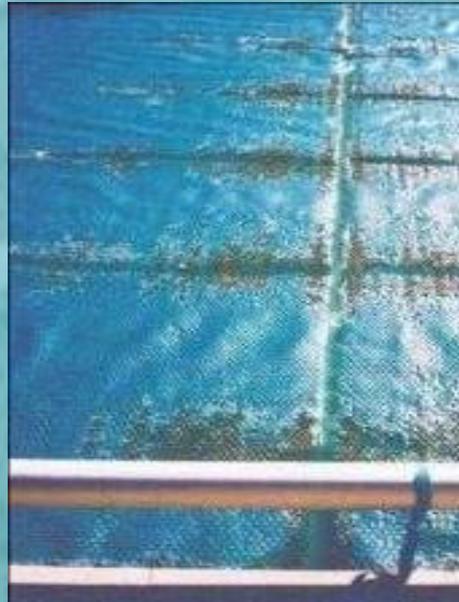
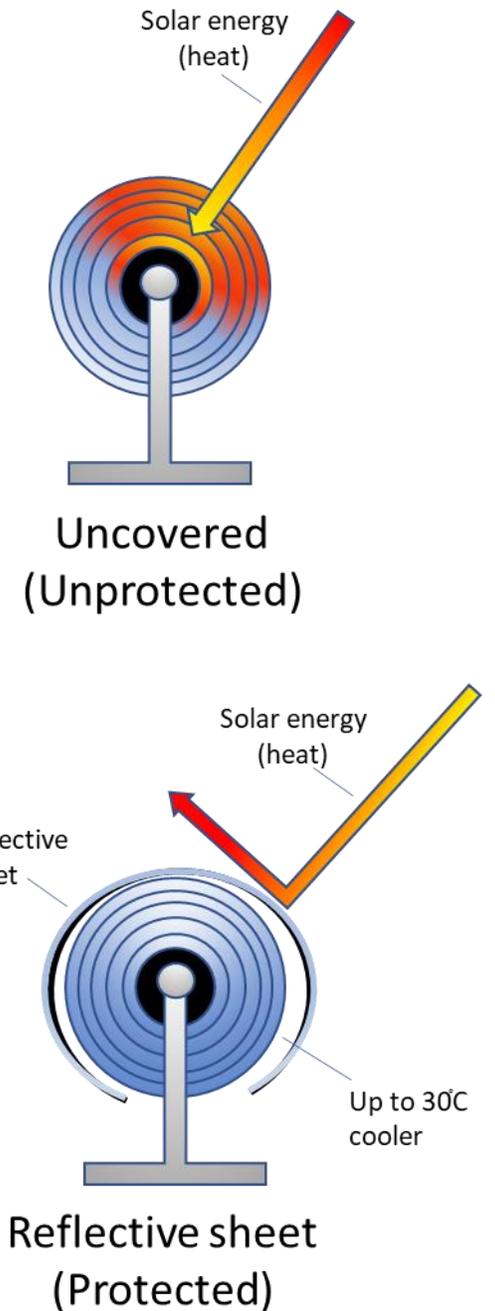
Overheating on the Reel System

A sadly common issue of improper storage can be identified by the bands of poor lay flat occurring across the pool.

Usually these bands increase in frequency as they get closer to the reel system, or the folding edges when fan folded. This occurs when the cover is stored in direct sunlight for a prolonged period of time.

Bubble Covers (solar Blankets) are designed to heat the water and insulate the pool to keep the heat in. When exposed on the reel system, this results in a rapid elevation in temperature at the centre of the roll. Tests conducted found temperatures of up to 80°C .

PE (polyethylene) is a thermoplastic which means it becomes malleable as the cover reaches its Vicat softening point. As the cover cools, the material sets to the shape of the reel and results in poor lay flat.

In extreme cases the covers can even oxidise or weld the layers of material together.

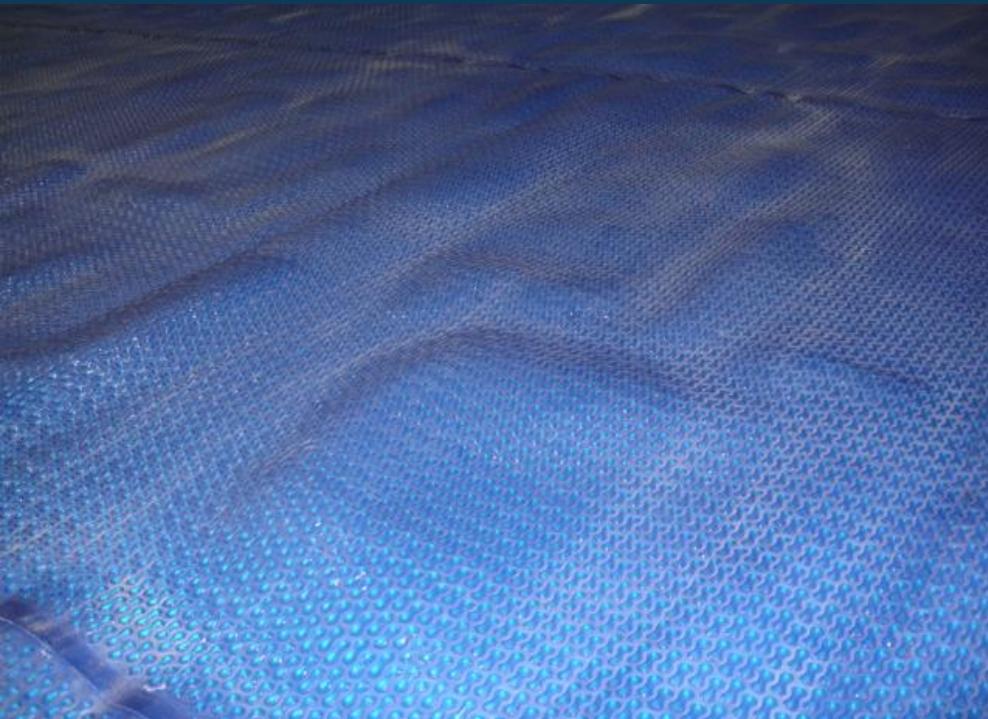
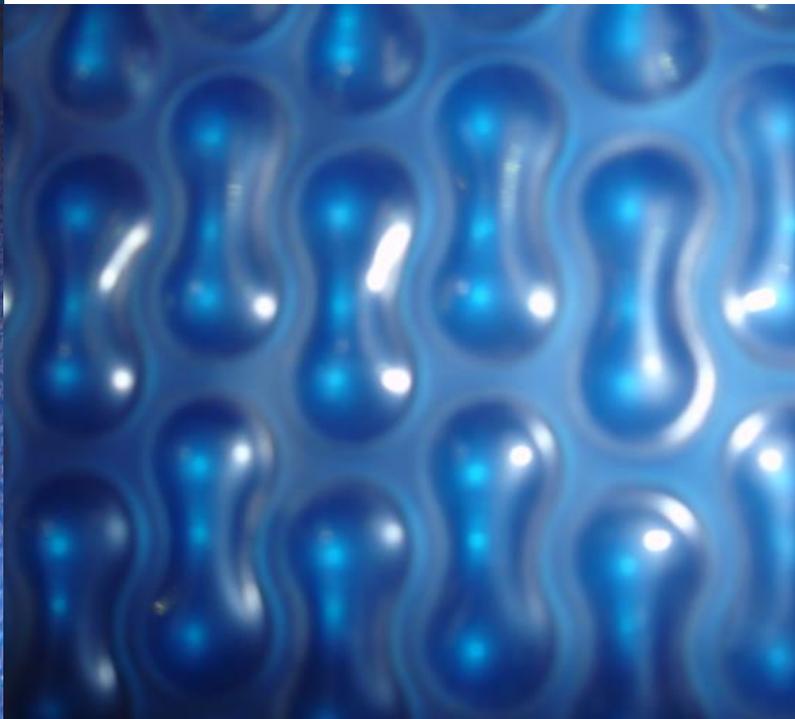
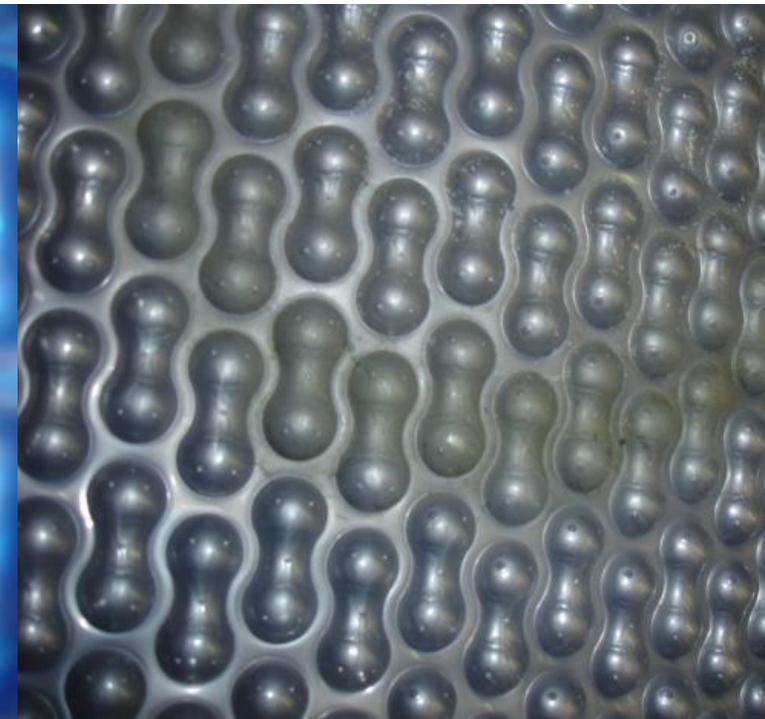
Bubble Expansion

Bubble swell is a rare cause for complaint and is often mistaken for shrinkage.

Although it is not entirely clear what exact conditions produce this effect, key factors seem to be atmospheric pressure, pool temperature and chemical levels.

- The bubble will resist compression.
- The cover material will have the appearance of lumps in random patches of the cover.

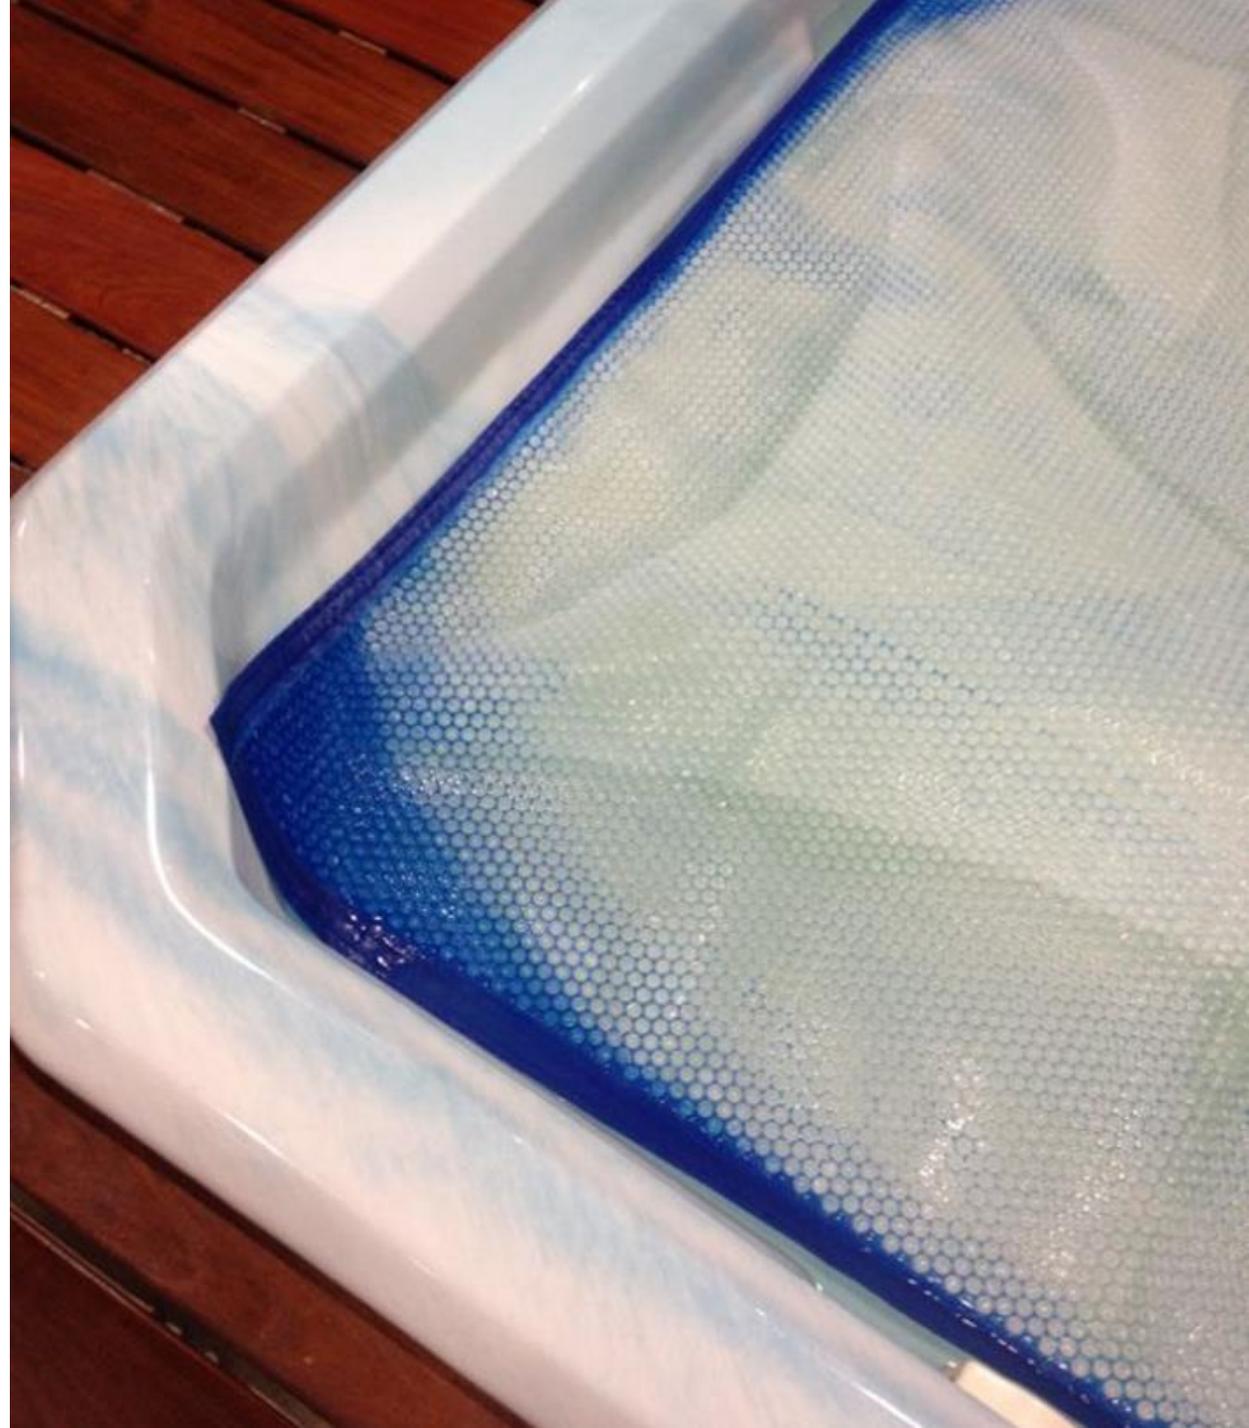
Bleached pigment

When a cover has been bleached, this is the result of high chemical level and is often assassinated by high temperatures such as on a hot tub.

The first indication of a the chemical degradation with be the bubbles on the underside of the cover.

Bleaching of the cover will normally be noticed once the bubble layer has started to become brittle and crack easily.

In extreme cases like in the images the cover has been used on a hot tub and the combination of high chemical levels and higher temperatures have resulted in a dramatic change in the covers appearance and properties.

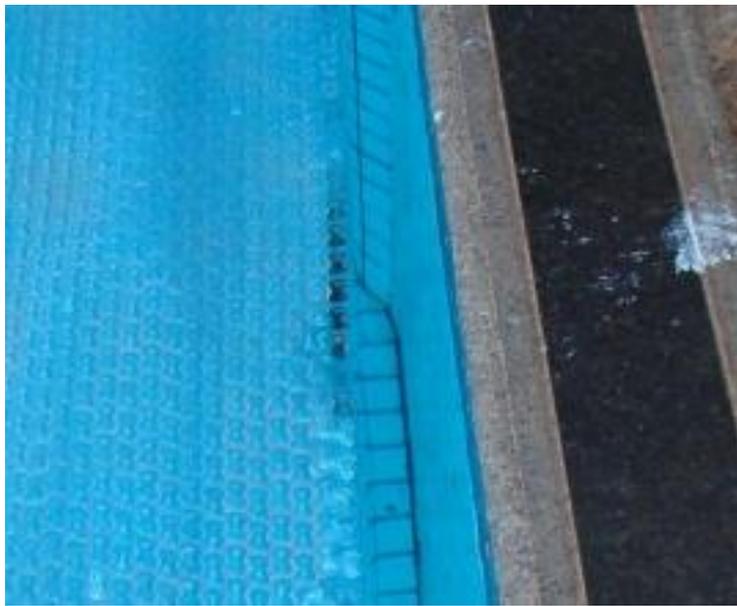
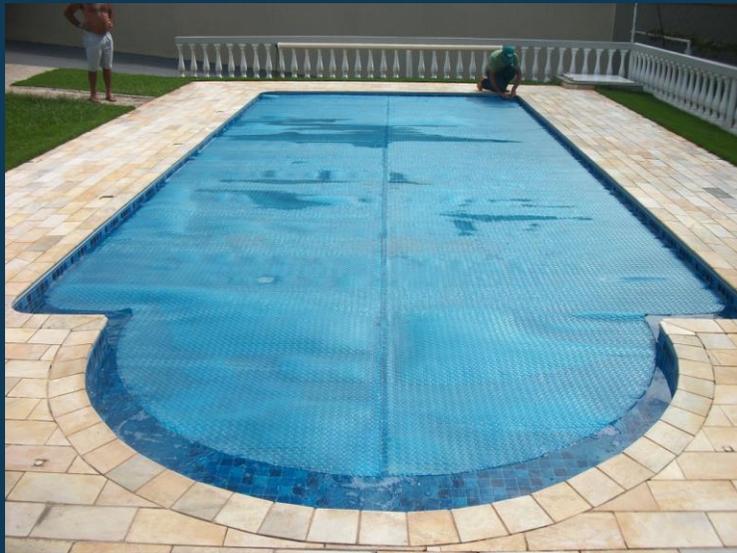
Shrinking Cover

Shrinkage of the cover can happen and is usually exaggerated by bubble swell.

Shrinkage is the result of the polymer in the material releasing stress as it gains molecular mobility.

As the material heats up the polymer gains the ability to release any stresses held within the material.

It has become a common part of industry's best practice to oversize the cover by 2% in its length to allow for a small amount of shrinkage as the cover settles on the pool.

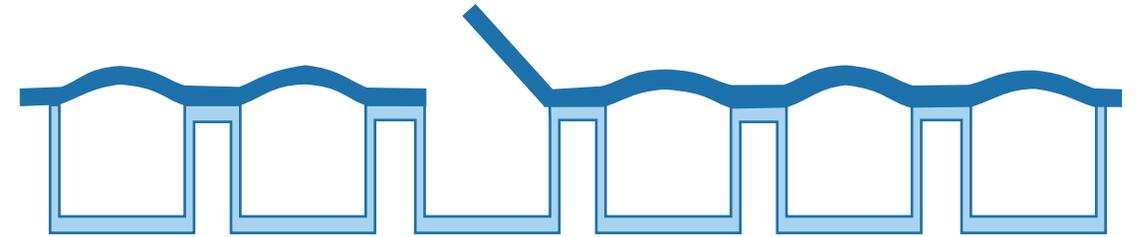
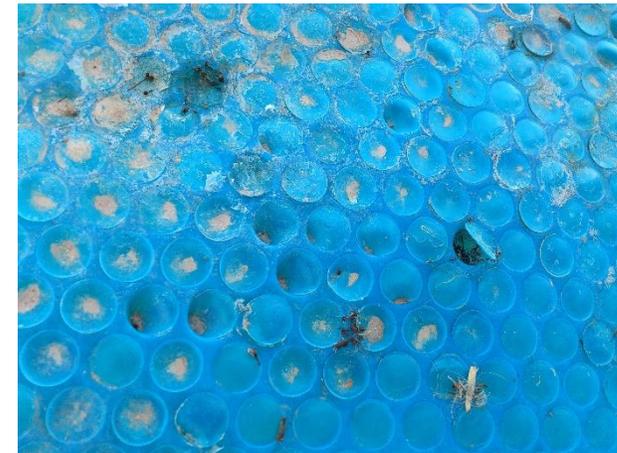
Bubble Collapse

The Bubbles on the under side of the cover deflate. Most commonly seen in 12mm materials as in the picture to the right.

This effect is very rare and can be caused by the build up of Nitrogen trichloride (NCl_3) which is one of the chloramines produced by the reaction of Hypochlorous acid (HOCl) and Ammonia (NH_3), derivatives in the warm water.

This is often a indication of a building in TDS (total dissolved solids) and CC (Combined Chlorine.)

The pool chemistry can be returned to balance by removing the cover and performing a break point chlorination or draining a portion of the loaded water with fresh.

Unfortunately once this has occurred the bubbles will not return to there previous state but actions taken to correct the issue will prevent this happen to a replacement cover.

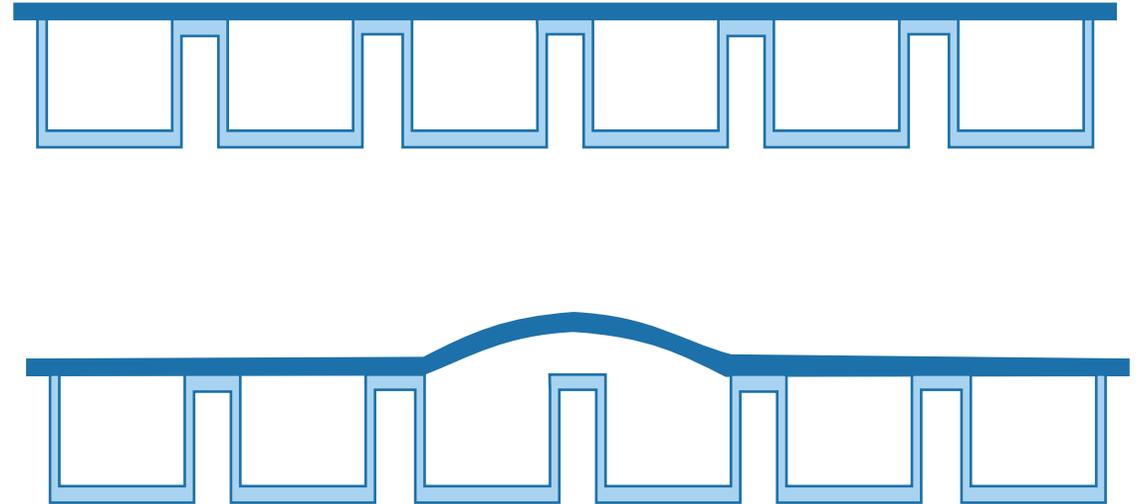
Delamination is incredibly rare and most often is the result of the cover overheating when being stored off the pool.

When folded or left on a reel system exposed the material quickly heats up and causes the air within the bubbles to expand.

In extremely rare cases this can result in the air expansion forcing the layers of material at the land area of the bubble separating.

This can be avoided with the implementation of a reflective storage sheet.

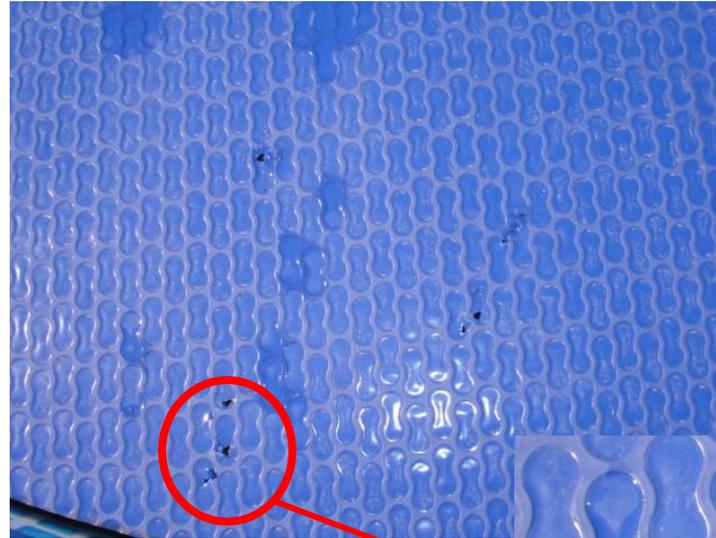
This is more common than would be imagined. Small groups of punctured or torn holes are often caused by birds.

Herring Gull attack!

We have found that a few CD's hanging from a string will cause reflections that discourage the birds from lingering around the pools.

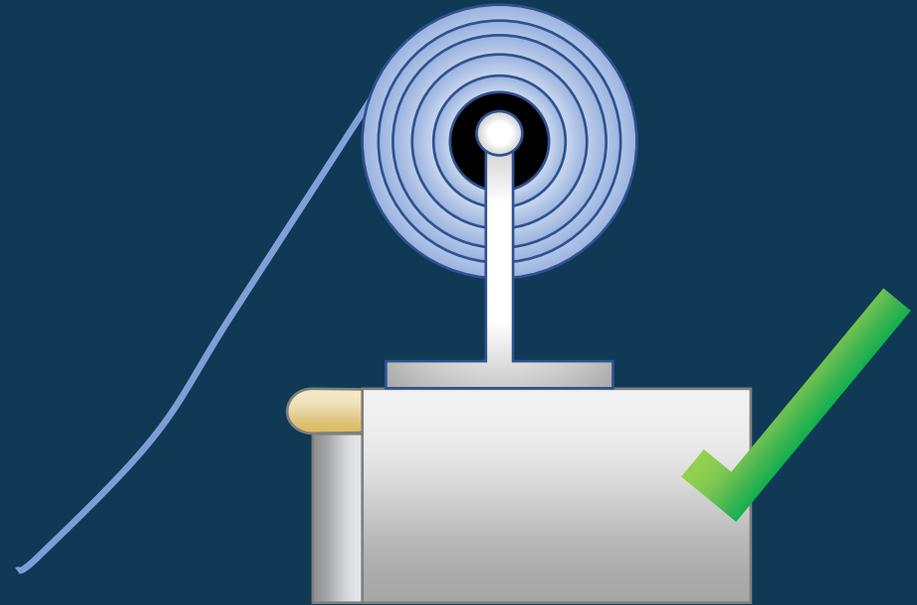
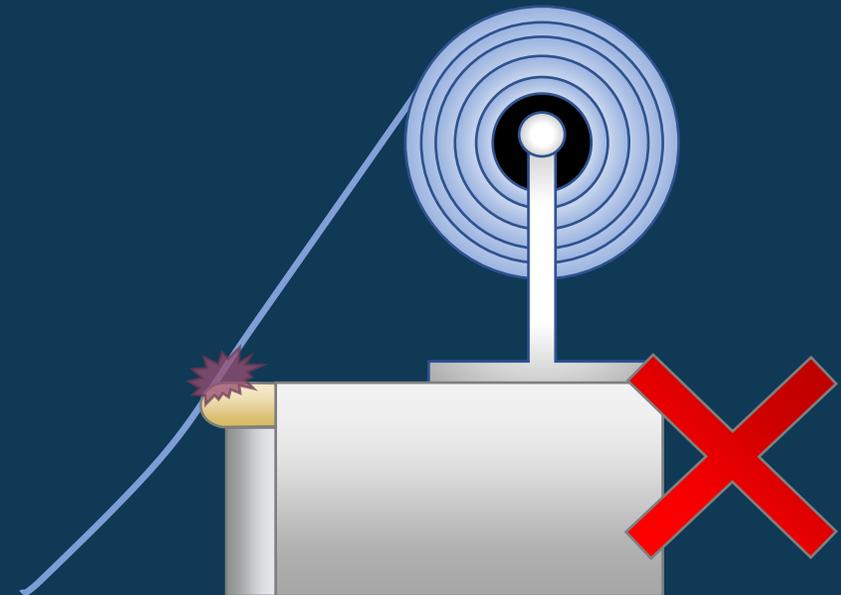
Water incursion into bubbles

As mentioned in the condensation section a unruptured bubble cannot fill with water.

Usually the most noticeable sign that a bubble or bubbles across the cover have ruptured is the propagation of algae or the build up of debris within the bubble.

A common cause, usually produced when a reel system is set to far back from the pool or the cover is removed by hand is a scuffing of the underside of the bubble. This causes a rupture through abrasion on rough surfaces and edges.

This is simple to identify by turning the cover over in the effected area and pressing down on the bubble. As the pressure builds you will see bubbles or water ejecting from the effected area.

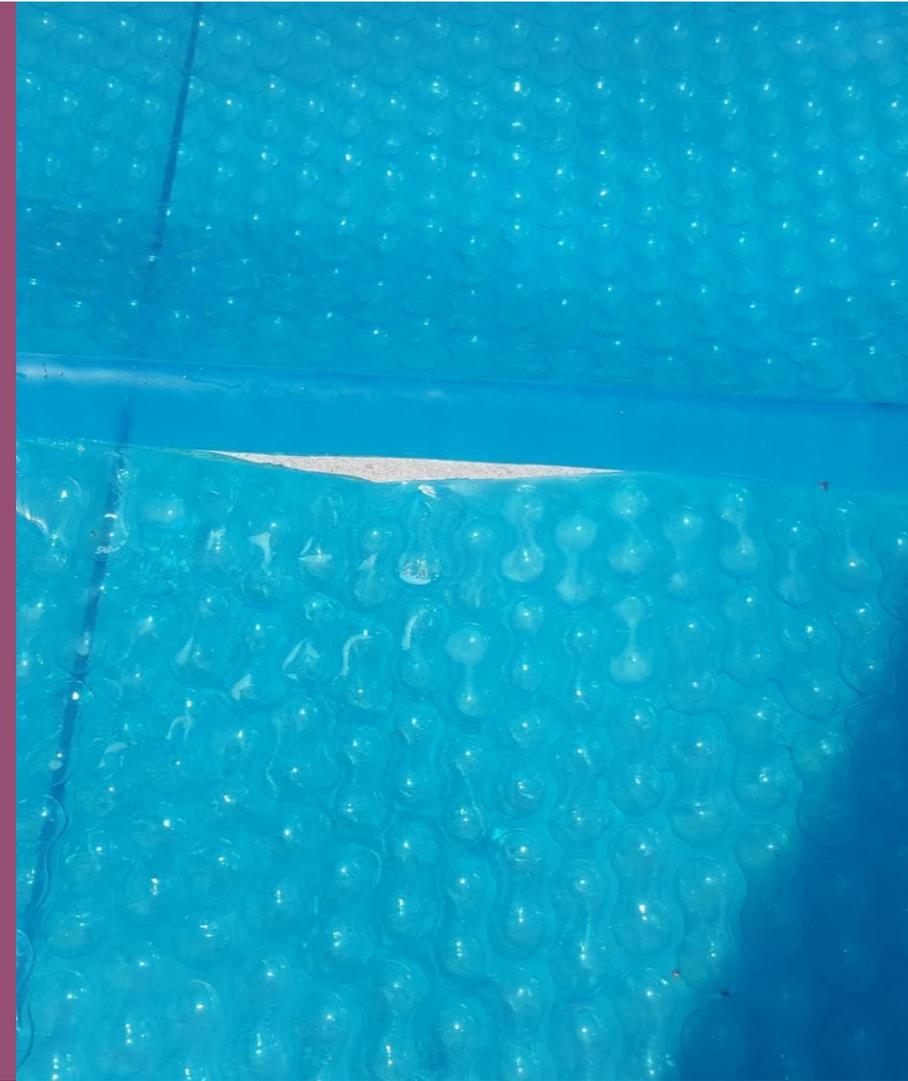
Splits at the weld edge

A score line is appears as a fine spilt next to the weld edge that shows no sign of polymer elongation.

Score lines are caused by damage to the material during welding. This can be due to:

- Residue build up on the wedge of the hot wedge welder.
- Dirt picked up from the floor being trapped on the wedge. Misalignment of the wedge.
- Too much compression from the pinch roller.

While there are tapes that can bond the materials together. This is not a permanent solution. If this occurs in the early days of the covers working life it is better to seek a replacement from the company who supplied the cover to you then attempt a repair.

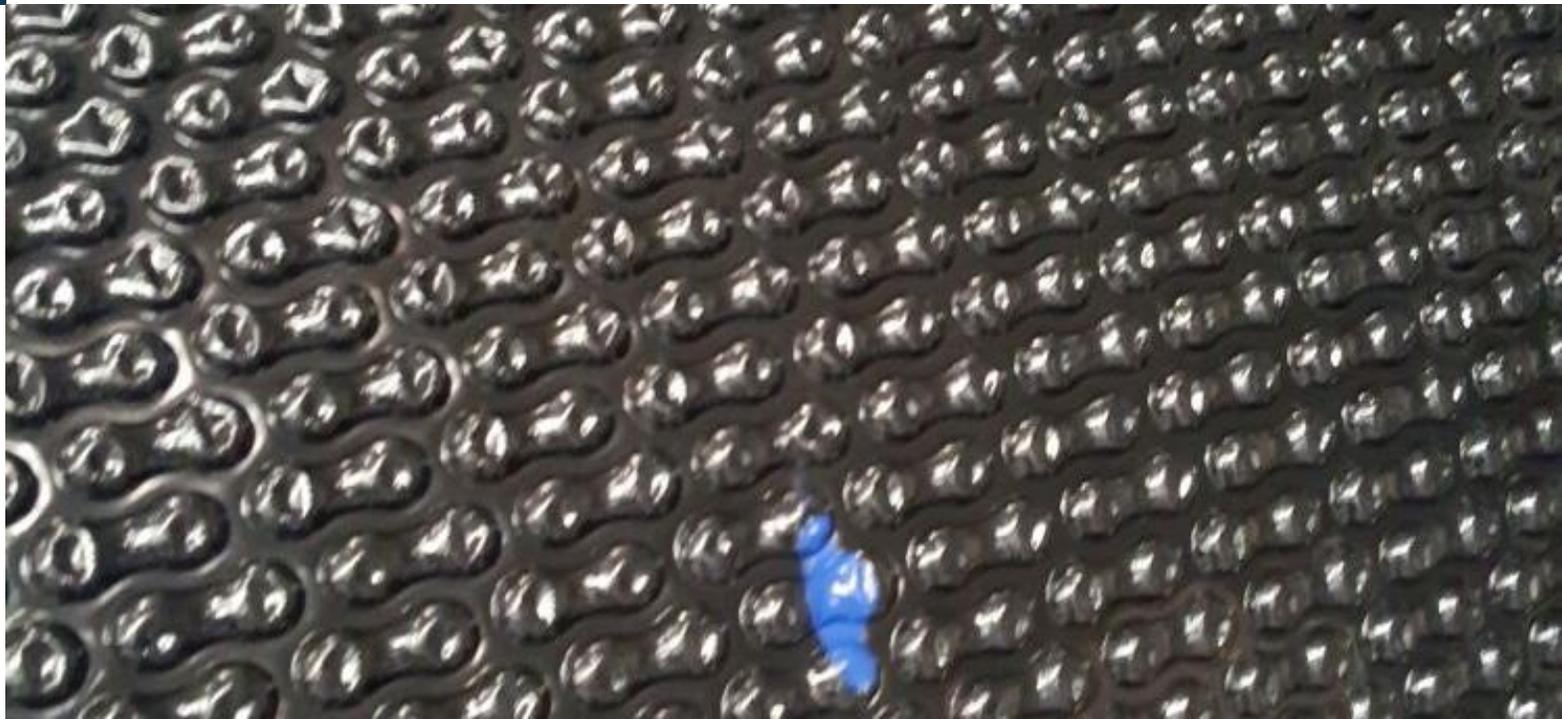
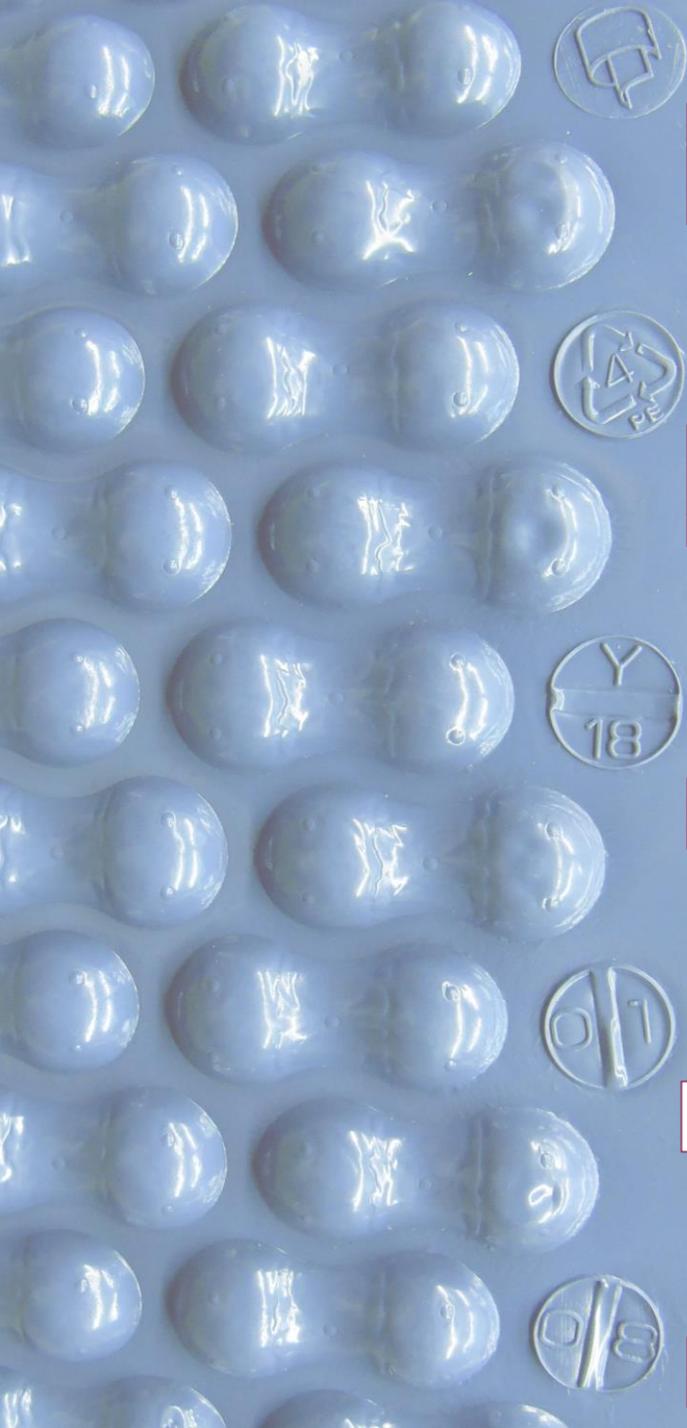
Lensing is caused by a rupture in one of the material films during production.

This can be caused by a process known as “Gelling” from the polymers or from a un-melted or carbonised piece of polymer or debris working its through the production line.

This results in a tear shaped deformation in the bubble. Lensing can appear in both the top and bubble layer.

On the top layer it will appear as a opening that exposes the inside of the bubble.

On the bubble layer it will pull the top layer down to form the bubble profile.

If you receive a roll with lensing that renders the material unusable. Please do not hesitate to contact us.

When contacting us please provide the date stamp or QC sheet. This way we can track the material, through our production and raw materials.
