WHO KILLED THE COVER?

A CHEMICAL GUIDE

PLASTIPACK LIMITEDTM
© Plastipack Ltd

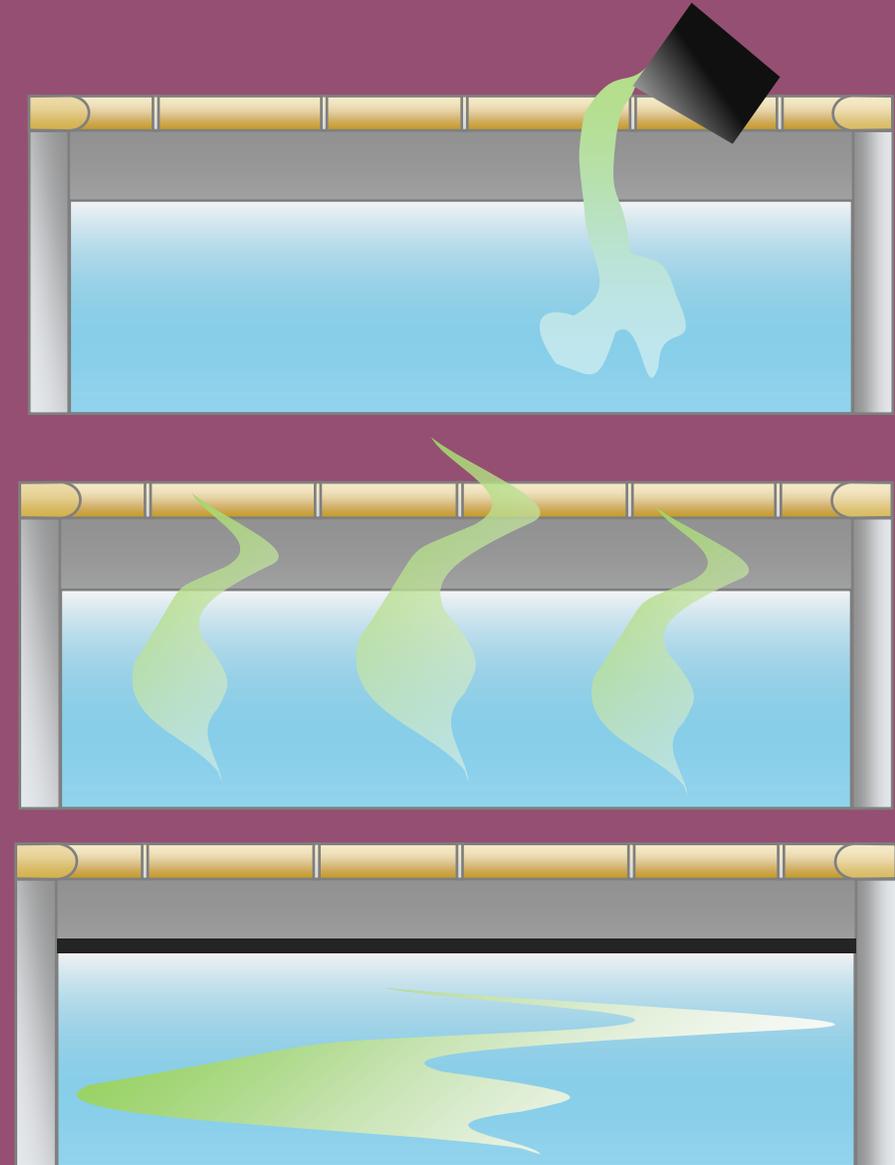
However, when a pool cover is left on during a shock dosing, the cover is exposed to the intense levels of the oxidant as well as trapping the by-products under the cover reducing the efficiency of the chemical treatment.

When the pool is outside of the industry recognised balance or when shock dosing the pool, it is important to remove the cover and only return it to the pool once oxidiser levels have stabilised.

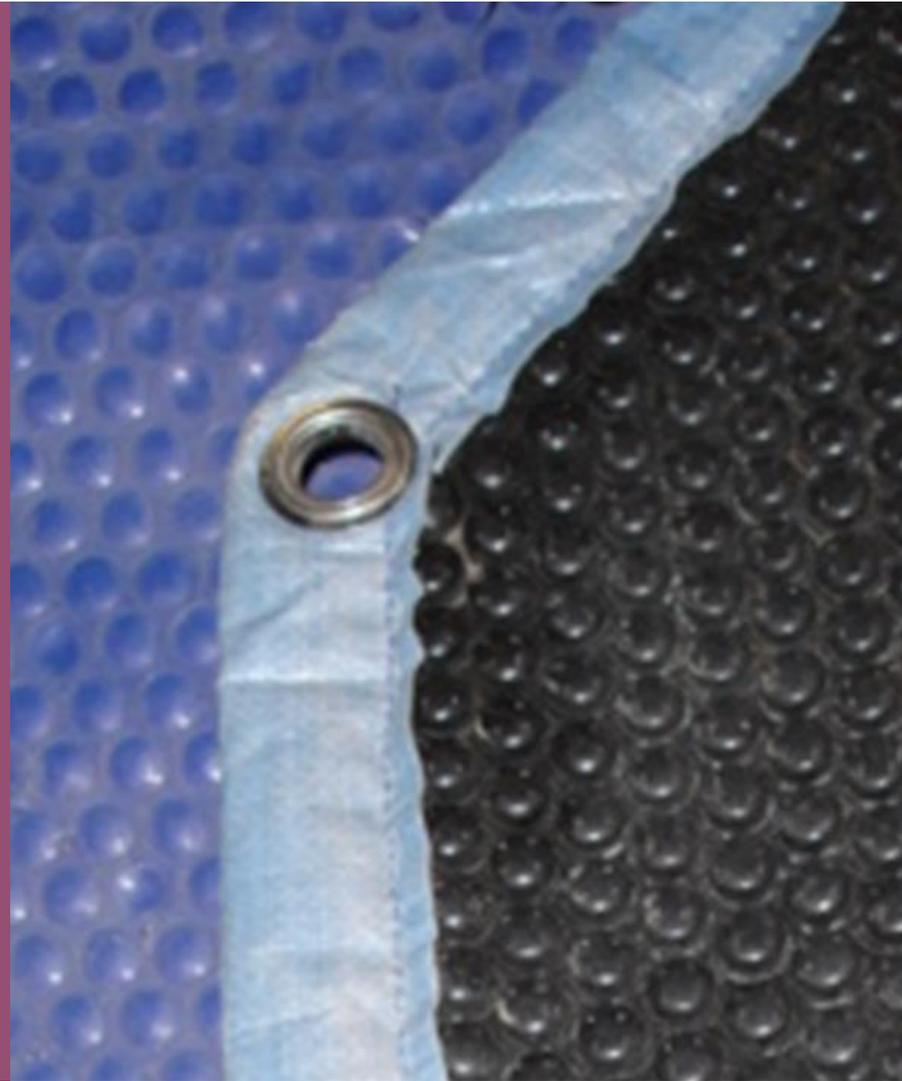
Most issues involving premature degradation are the result of elevated chemical levels within the pool.

Frequently, a sudden deterioration of the cover can be the result of a shock treatment.

Noticeable effects:

- Bleaching of the underside of the cover.
- Bleaching of the hemming/edge.
- Material has turned brittle - in particular on the bubble layer.
- High residue amounts on the cover.
- Oxidation of eyelets.
- Strong chlorine smell

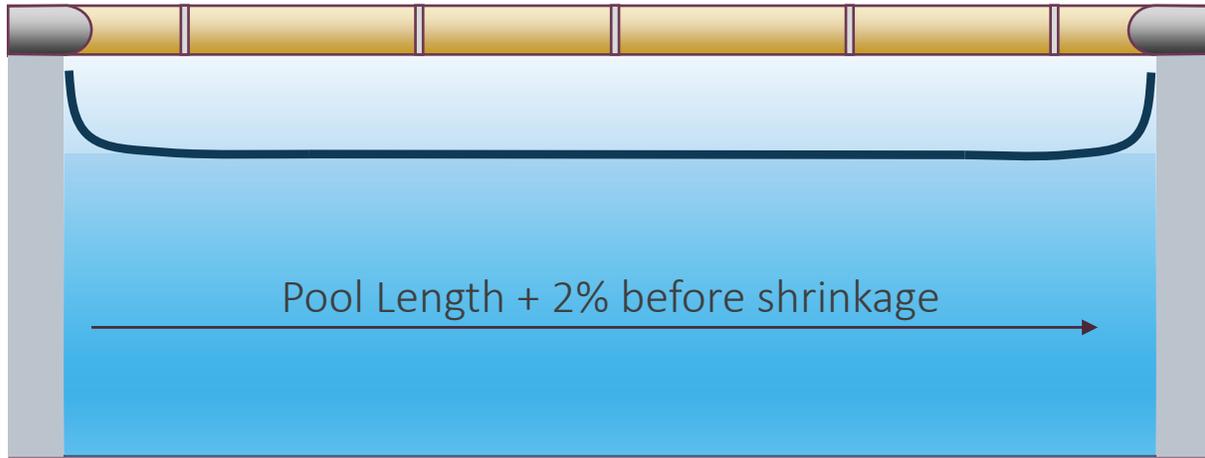
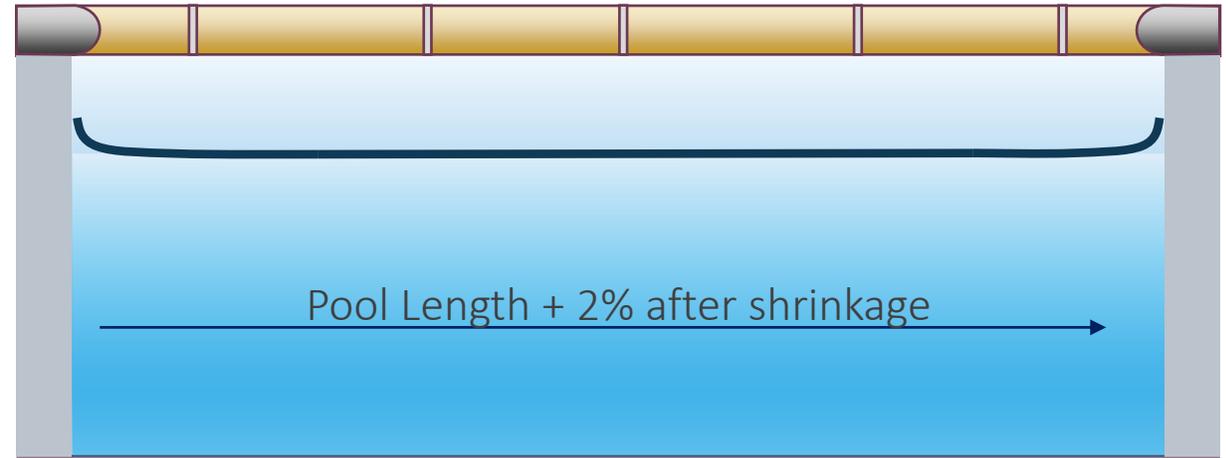
Shrinking Cover

Shrinkage is the result of the polymer in the material releasing stress as it gains molecular mobility.

As the material heats up the polymer gains the ability to release any stresses held within the material.

As a result of this Plastipack aims to remove as much stress from the material as possible. Because of this, should shrinkage be triggered, the material should only shrink between 1% and 2% of its total length.

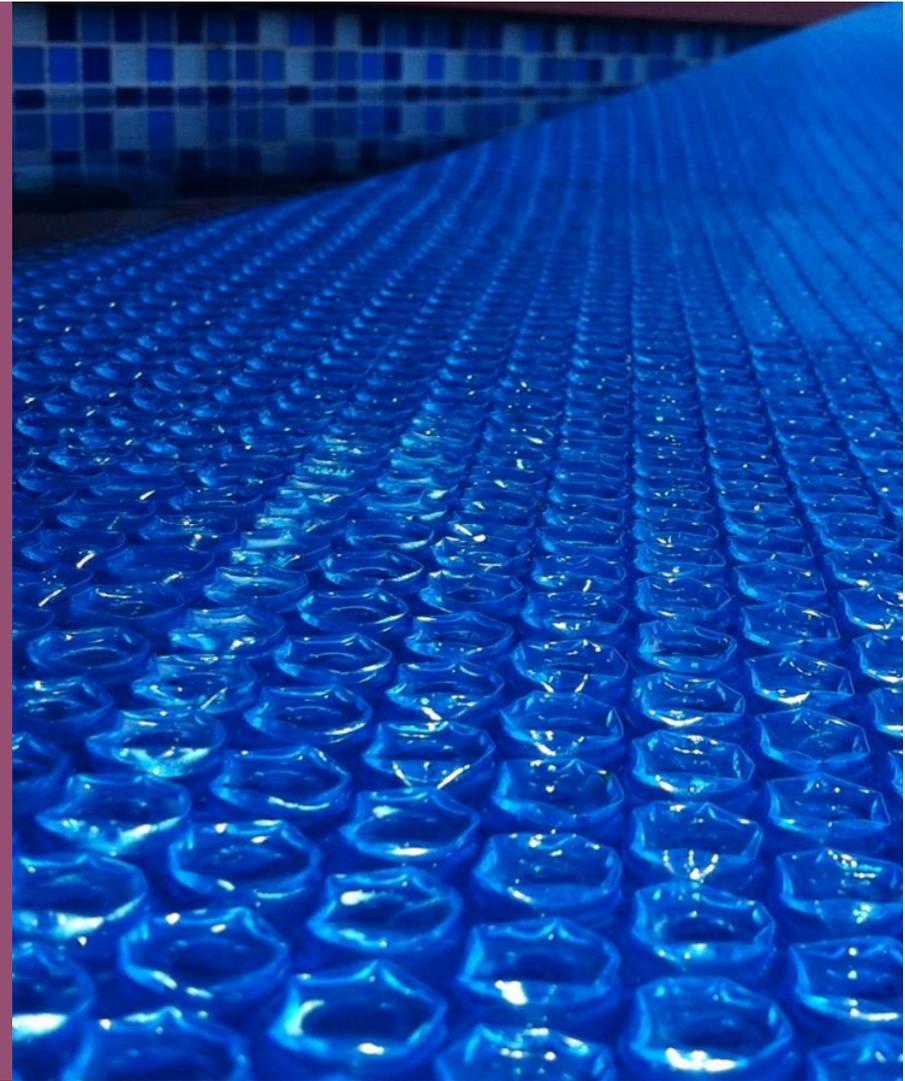
This effect is very rare and can be caused by the build up of Nitrogen trichloride (NCl_3) which is one of the chloramines produced by the reaction of Hypochlorous acid (HOCl) and Ammonia (NH_3), derivatives in the warm water.

The pool chemistry can be returned to balance by removing the cover and performing a break point chlorination or draining a portion of the loaded water with fresh.

Unfortunately once this has occurred the bubbles will not return to there previous state but actions taken to correct the issue will prevent this happen to a replacement cover.

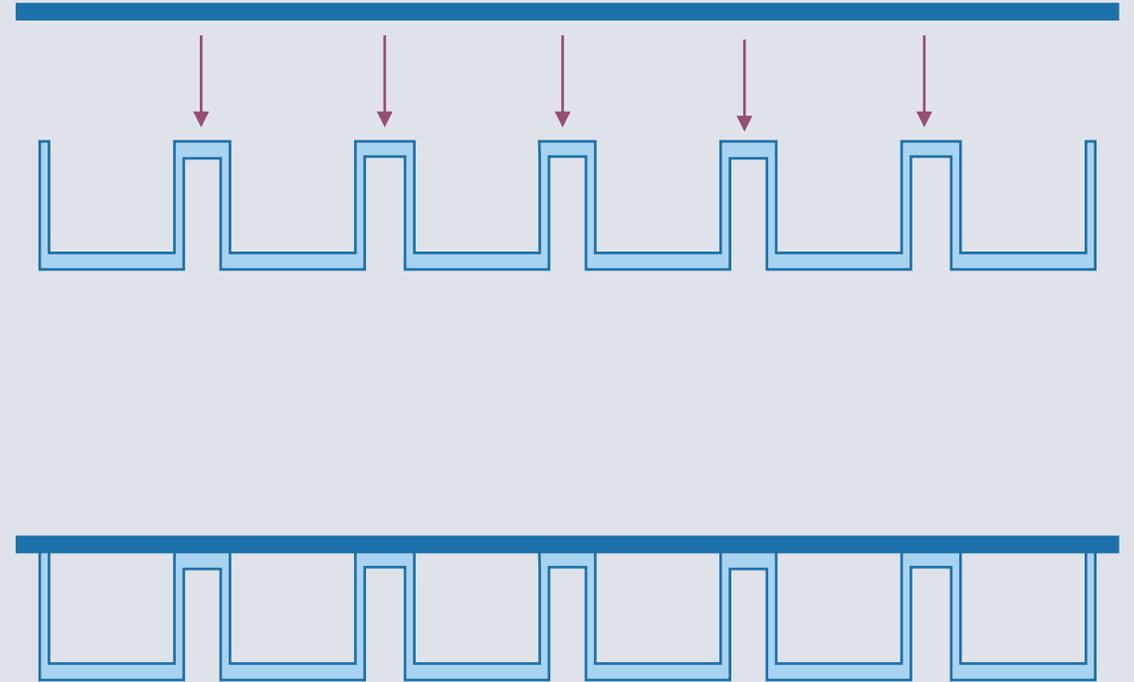
Delamination is incredibly rare and most often is the result of the cover overheating when being stored off the pool.

When folded or left on a reel system exposed the material quickly heats up and causes the air within the bubbles to expand.

Should delamination occur without indications of improper storage please contact Plastipack immediately.

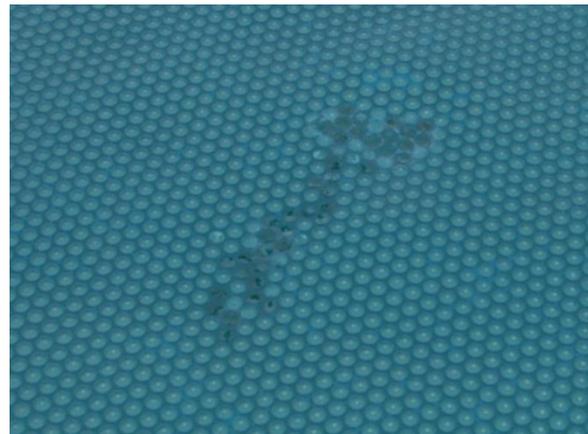
Magpie

This is more common than would be imagined. Small groups of punctured or torn holes are often caused by birds.

We have found that a few CD's hanging from a string will cause reflections that discourage the birds from lingering around the pools.
